USS Slater: Preparing to go to the shipyard for Mast Restoration and Preservation

The Mast is one of the last parts of the ship that has not received a comprehensive overhaul. It has been at least 25 years since the mast has received attention.

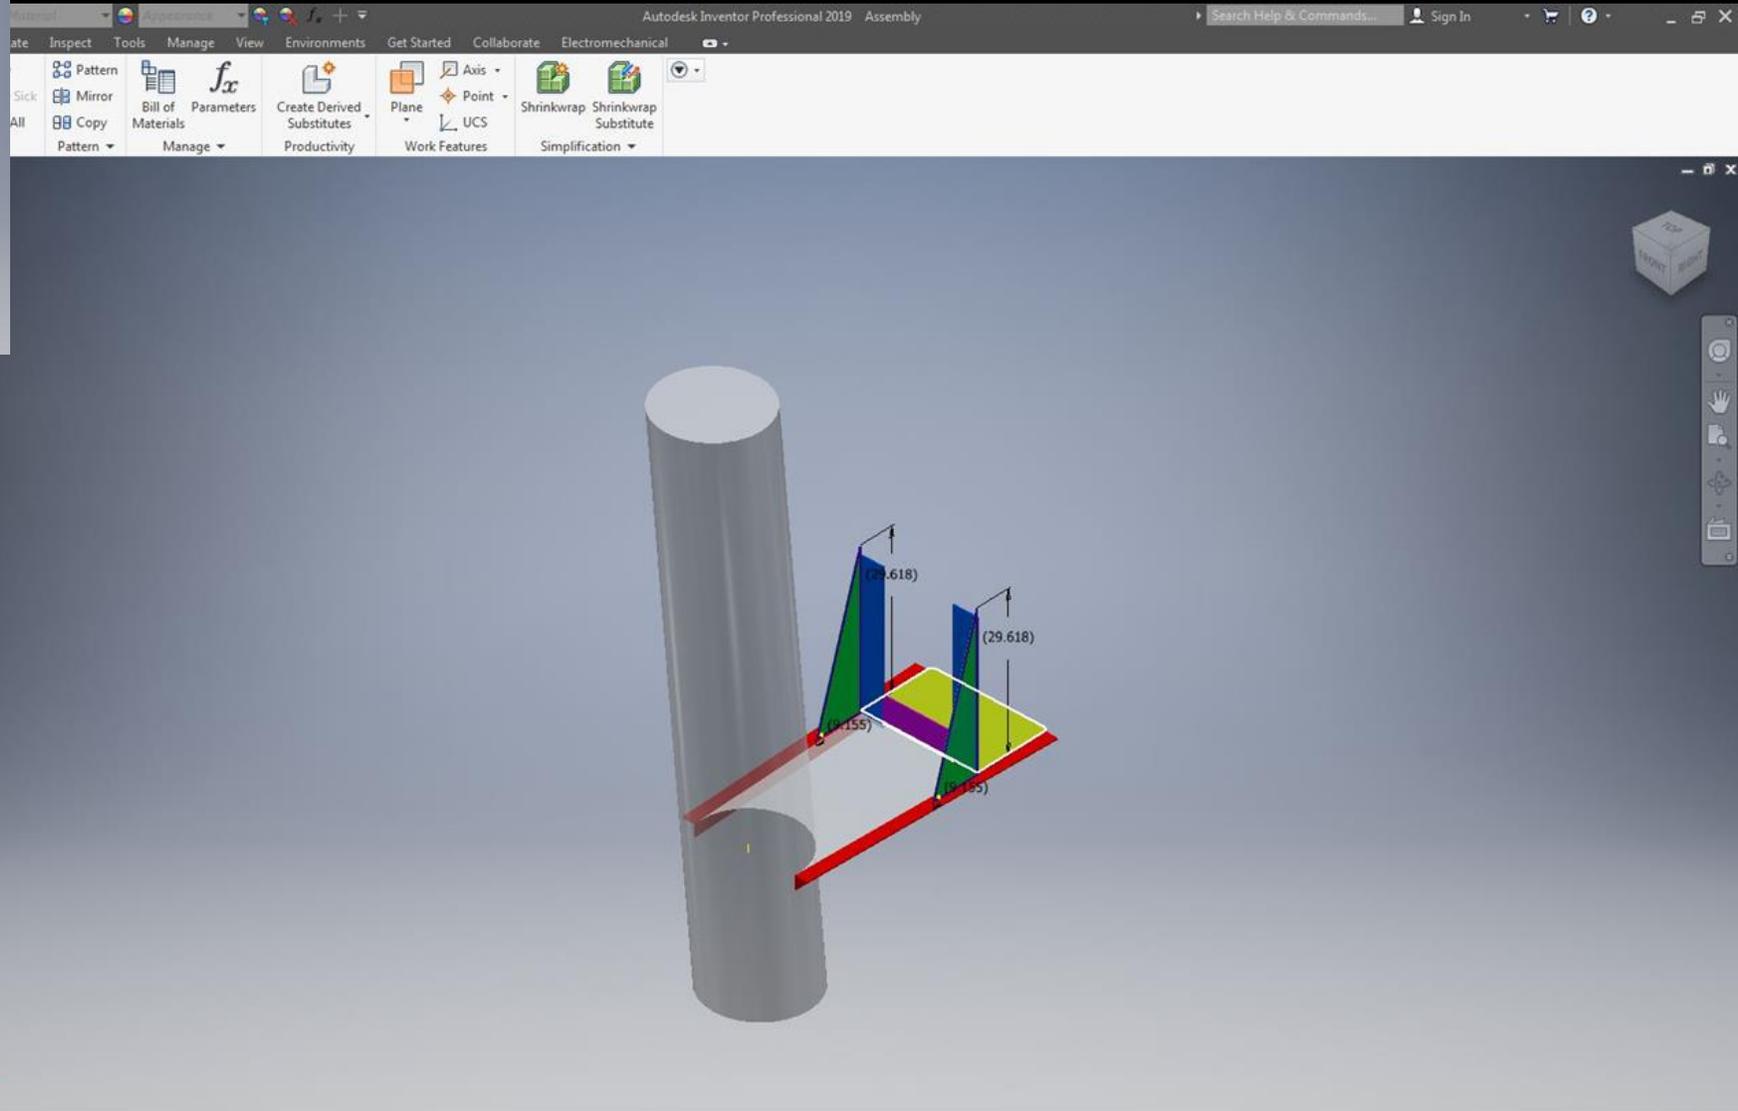
Original parts are severely corroded. We made new ones.

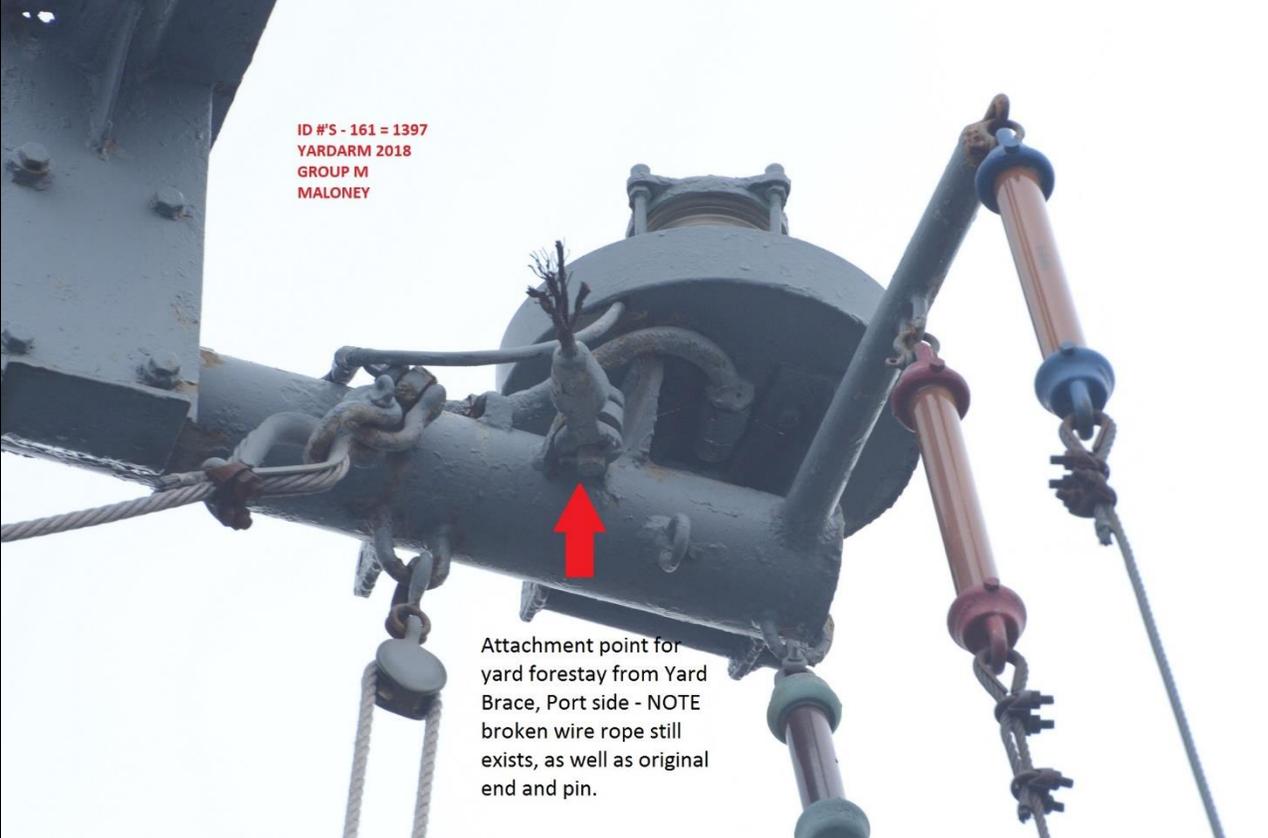
Attachment point for
yard forestay from Yard
Brace, Port side - NOTE
broken wire rope still
exists, as well as original
end and pin.
